FAA-NA-77-35

FAA/RD-77-13

# FULL-SCALE AIRCRAFT CRASH TESTS OF MODIFIED JET FUEL

Robert H. Ahlers

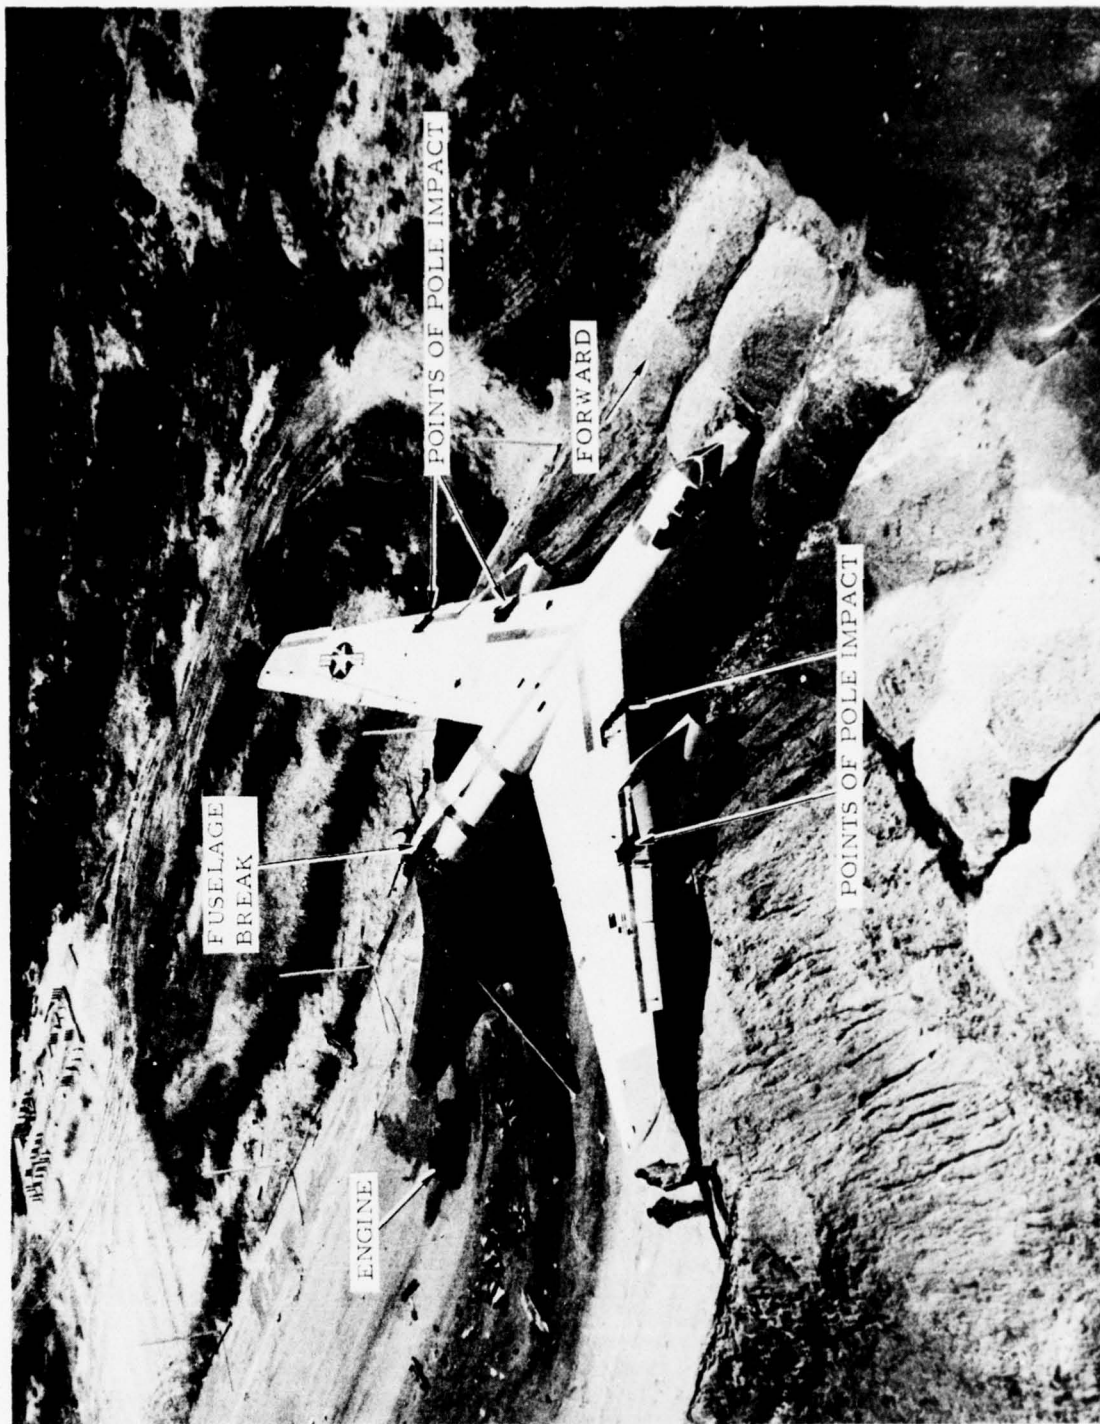
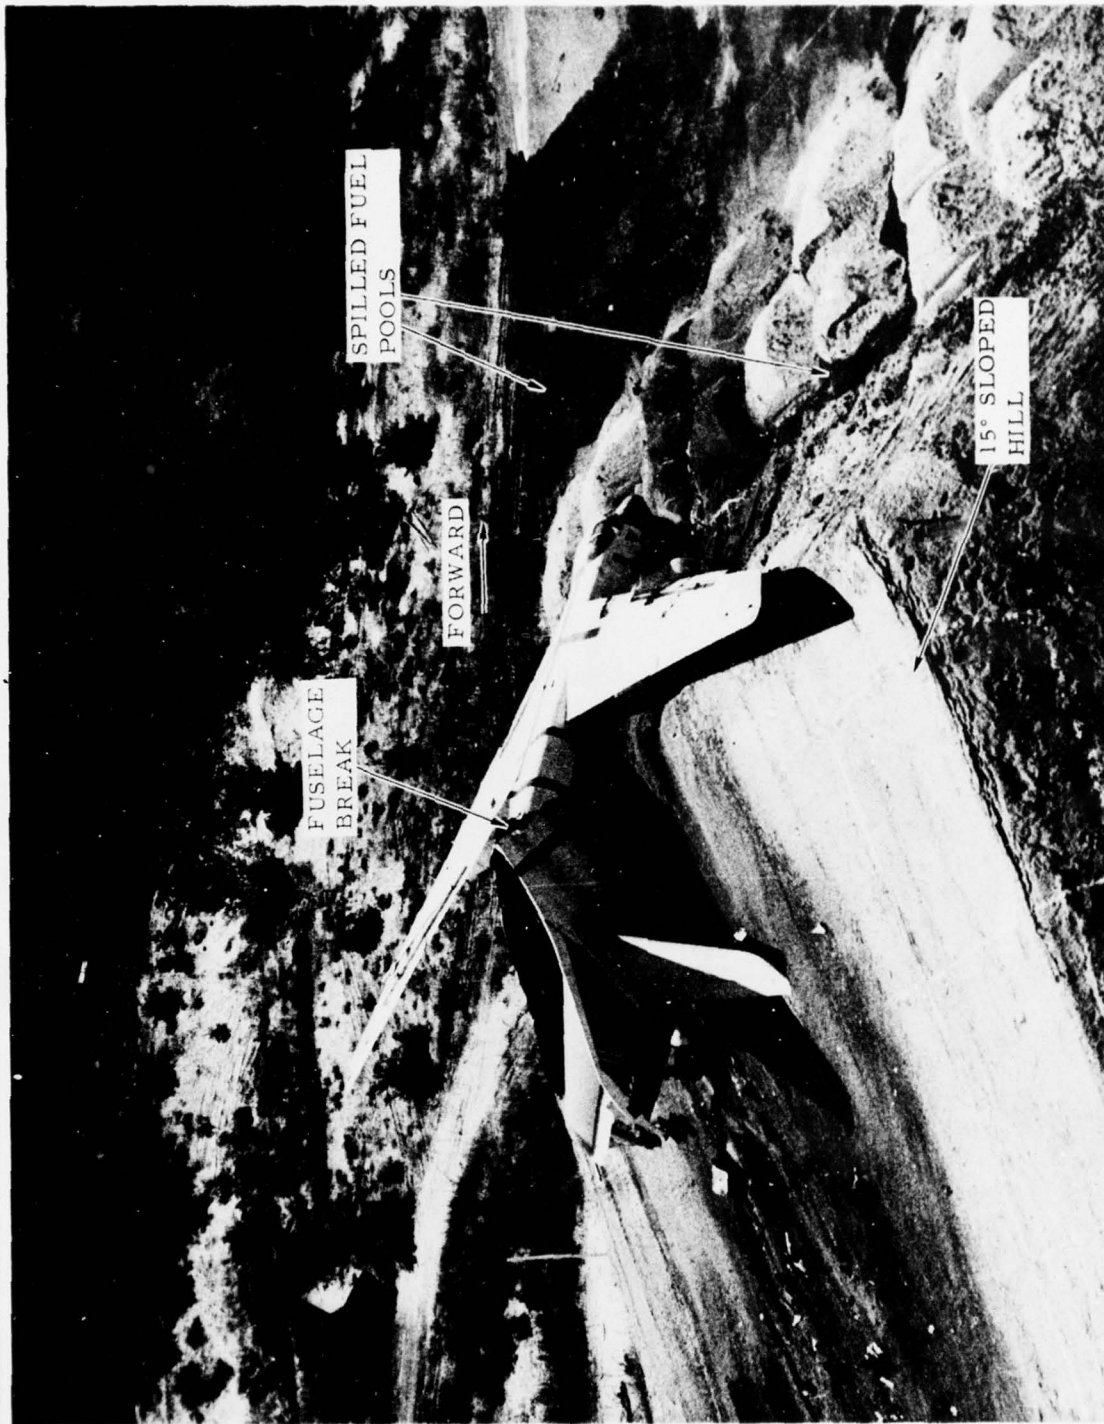
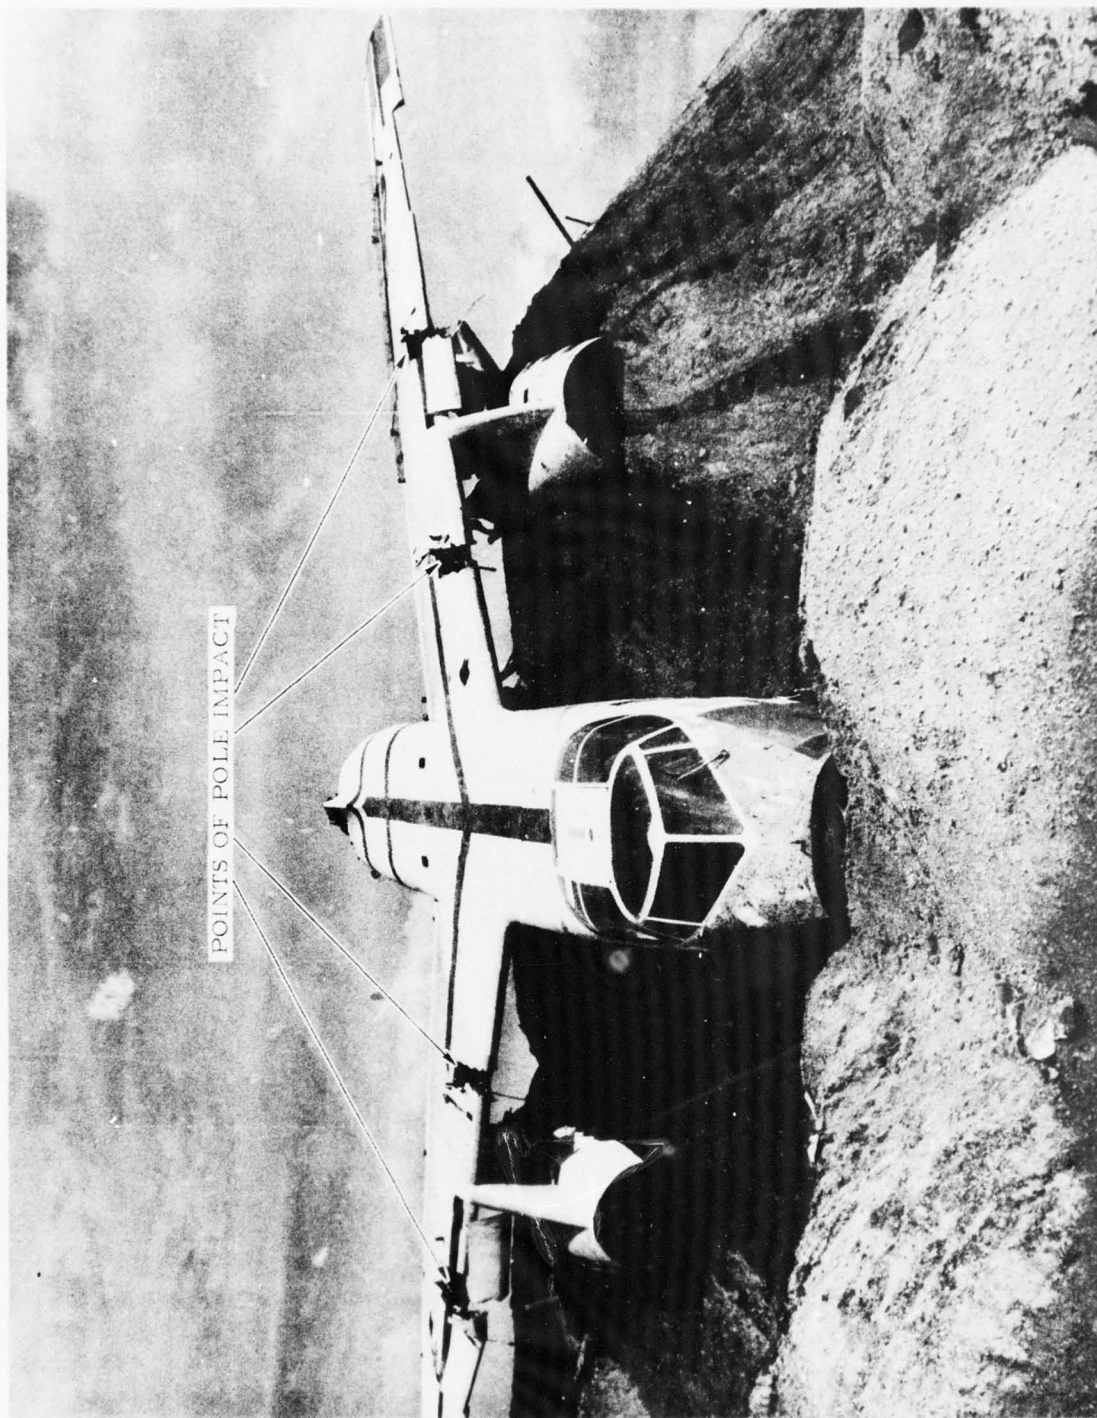
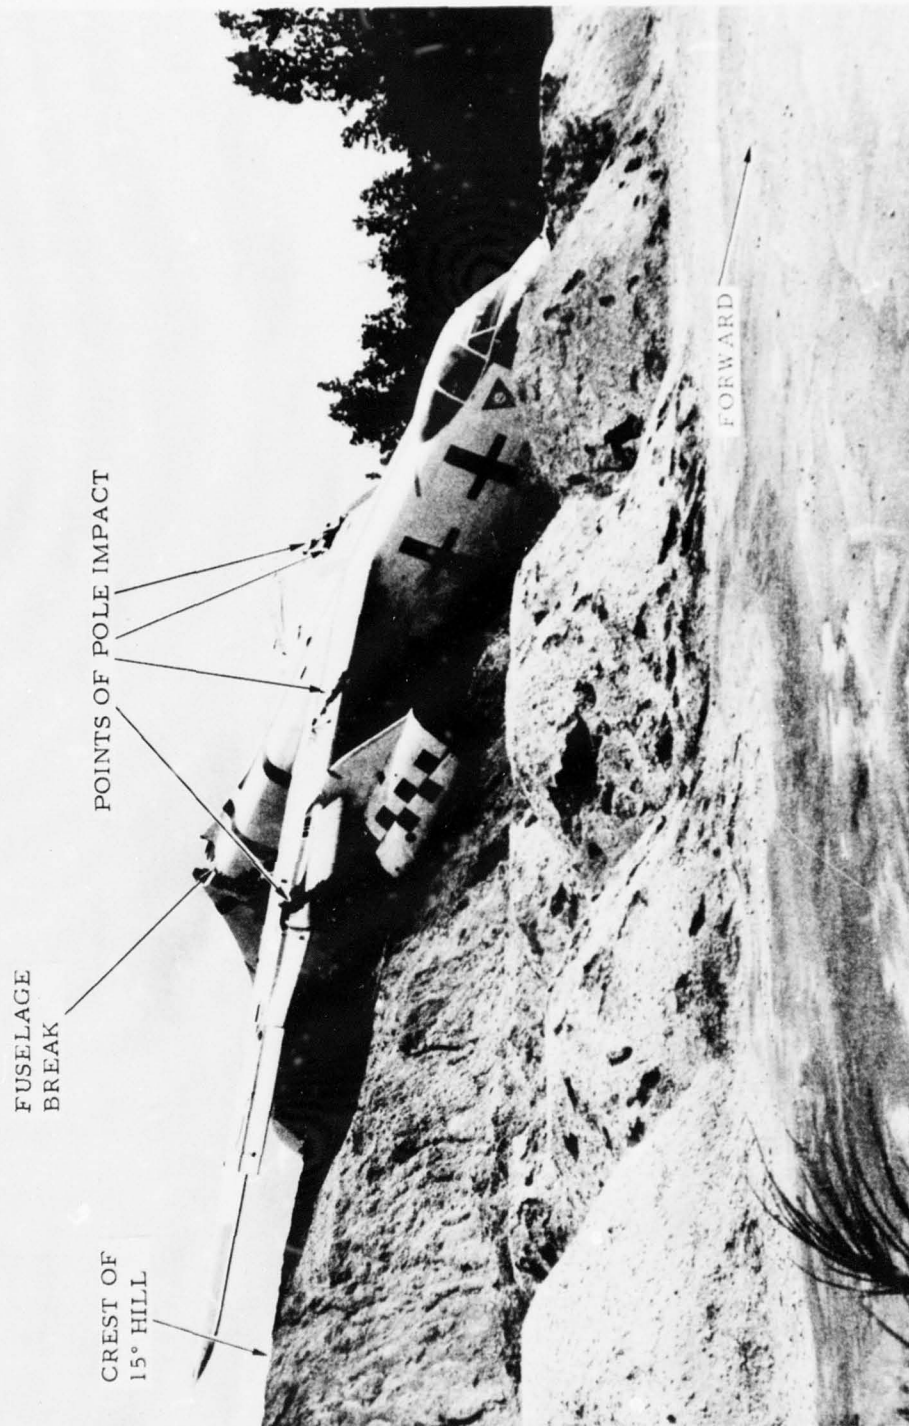
FIGURE 9. A3 AIRPLANE OF TEST NO. 2 (OVERHEAD RIGHT FRONT VIEW)

FIGURE 10. A3 AIRPLANE OF TEST NO. 2 (OVERHEAD RIGHT REAR VIEW)

FIGURE 11. A3 AIRPLANE OF TEST NO. 2 (GROUND FRONTAL VIEW)

FIGURE 12. A3 AIRPLANE OF TEST NO. 2 (GROUND RIGHT FRONT VIEW)

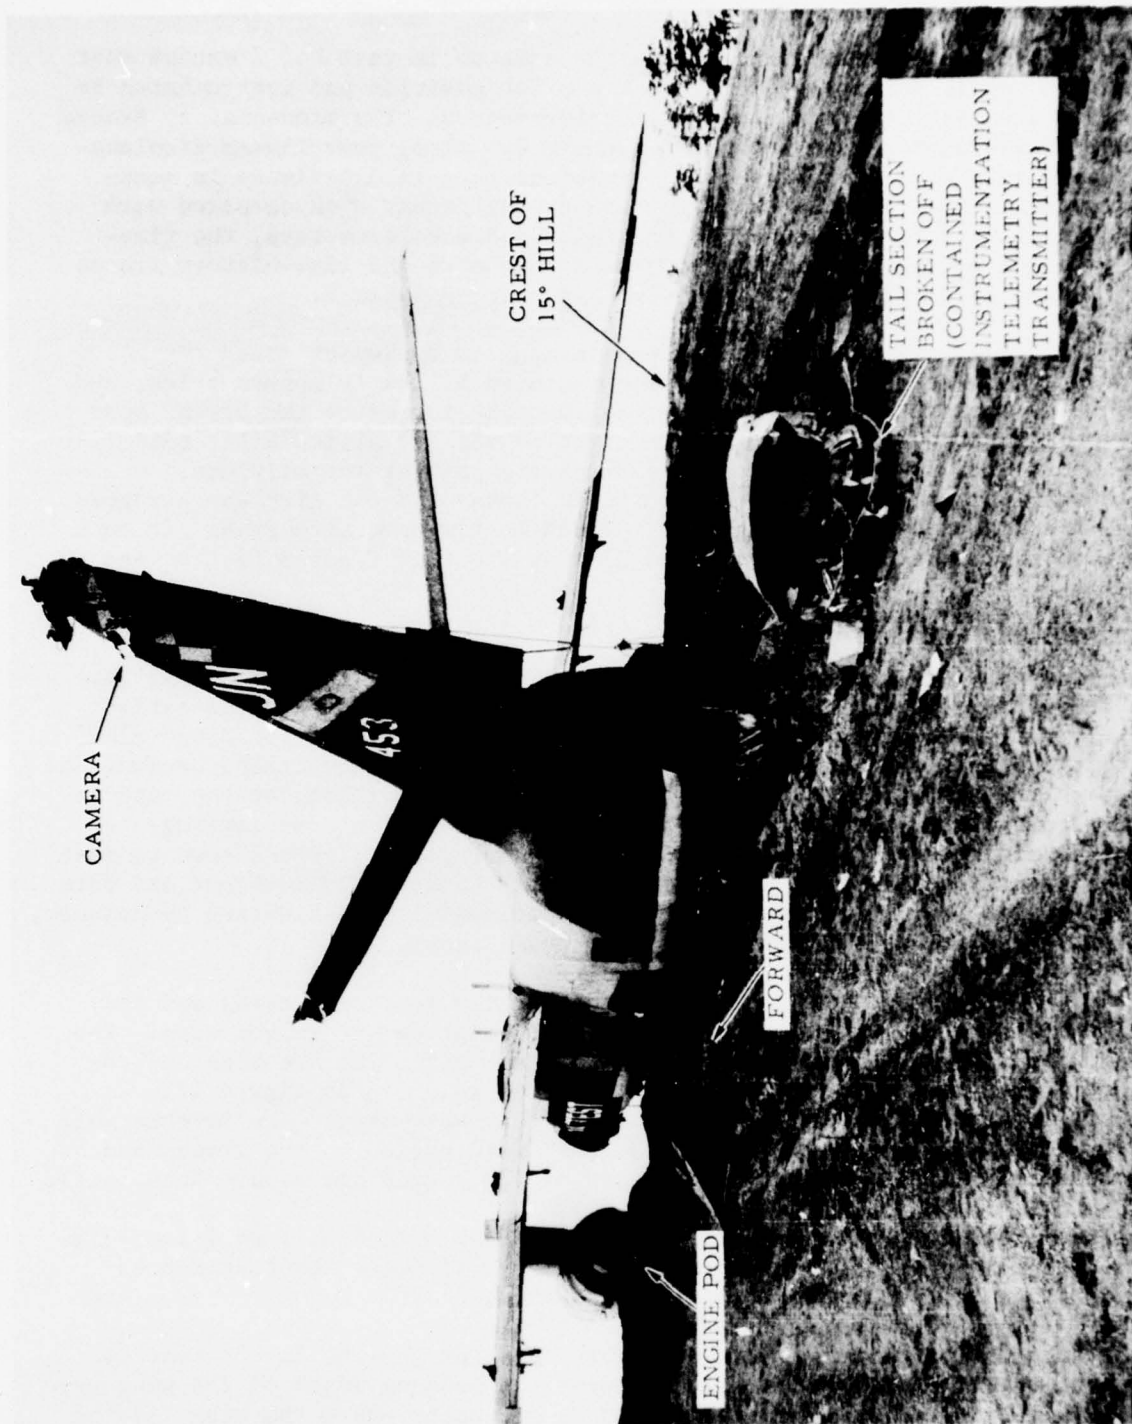
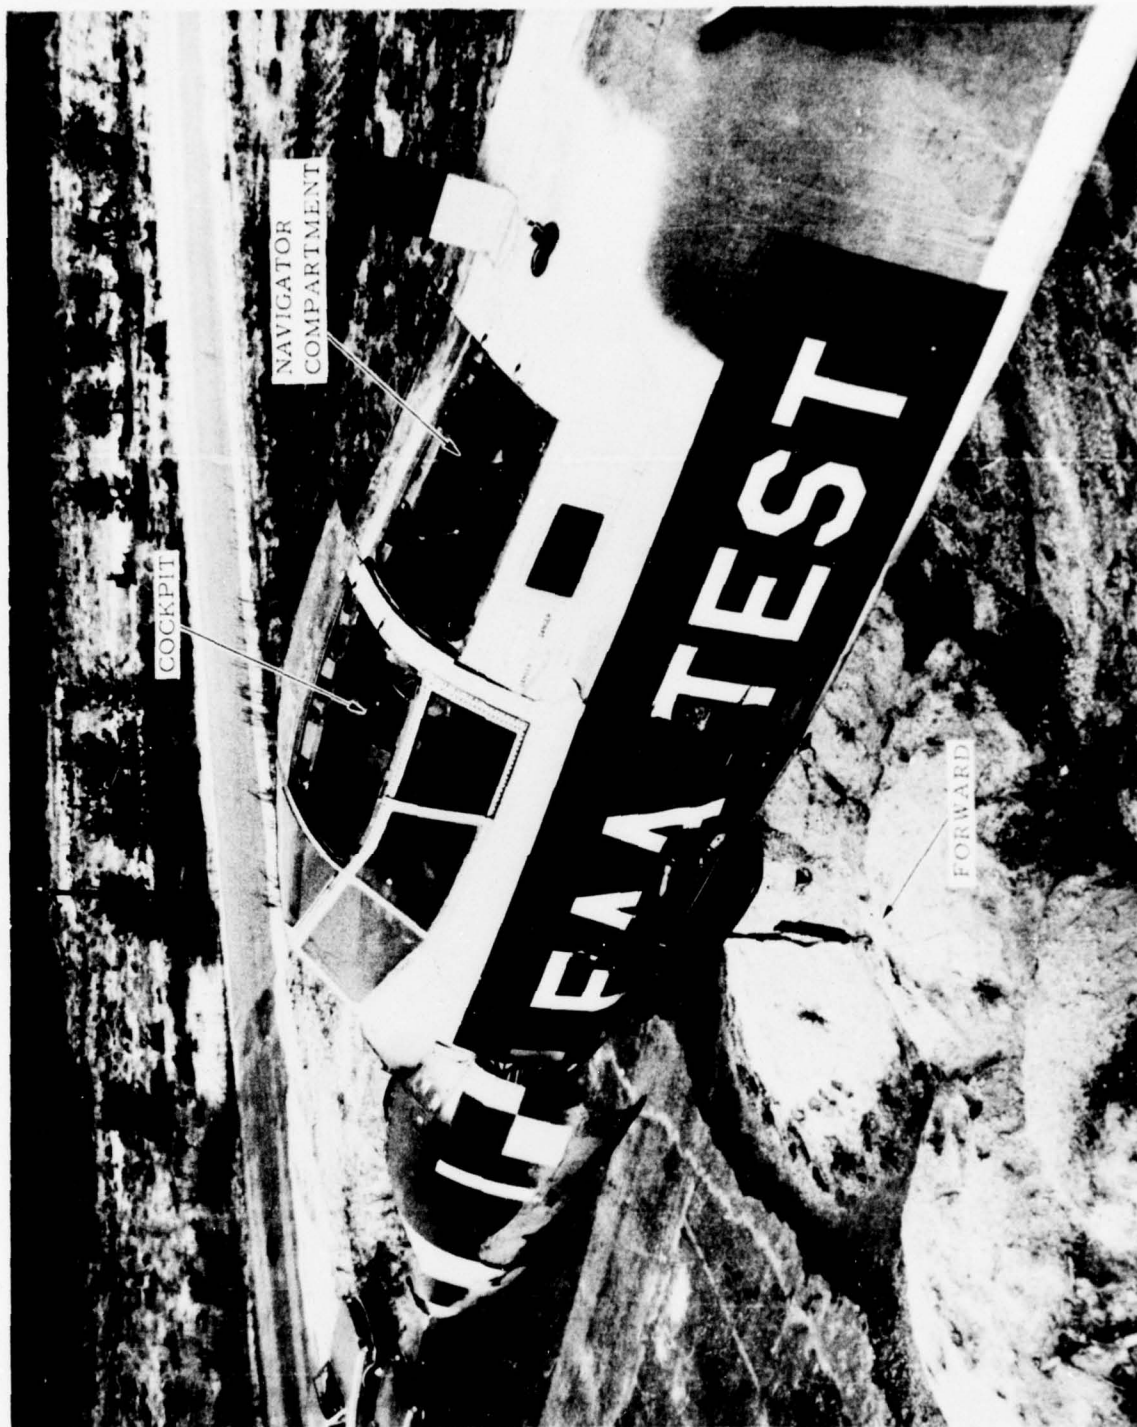
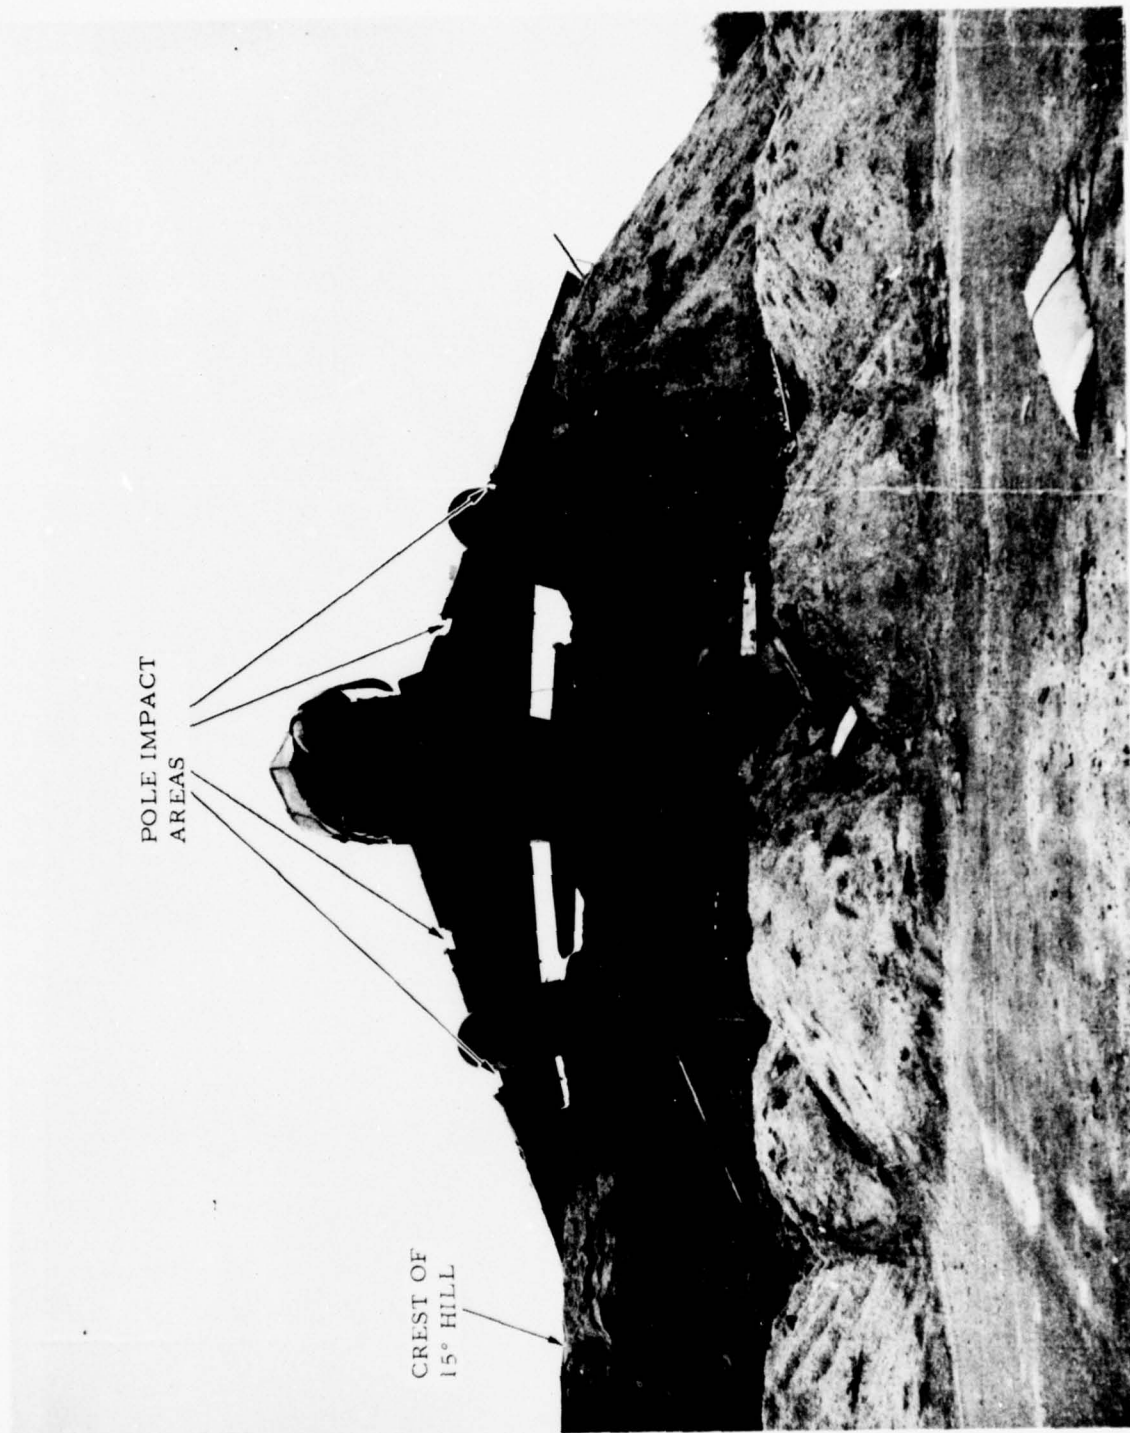
The RB66 airplane was accelerated by the jet car to an impact speed of 105 knots. The integral wing tanks were ruptured by the telephone poles, and the modified fuel spilled out through the channels formed by the broken spar web. The airplane came to rest on the crest of the 15° sloped hill, but did not burn; nor were there any fires along the path of the airplane, even though fuel spilled out of the ruptured tanks, and the airplane ploughed through the ignition sources that were placed in the test site area. It came to rest on the crest of the 15° sloped hill as shown in figures 14, 15, and 16.

FIGURE 14. RB66 AIRPLANE OF TEST NO. 3 (LEFT REAR VIEW)

FIGURE 15. RB66 AIRPLANE OF TEST NO. 3 (LEFT SIDE VIEW)

FIGURE 16. RB66 AIRPLANE OF TEST NO. 3 (GROUND FRONTAL VIEW)

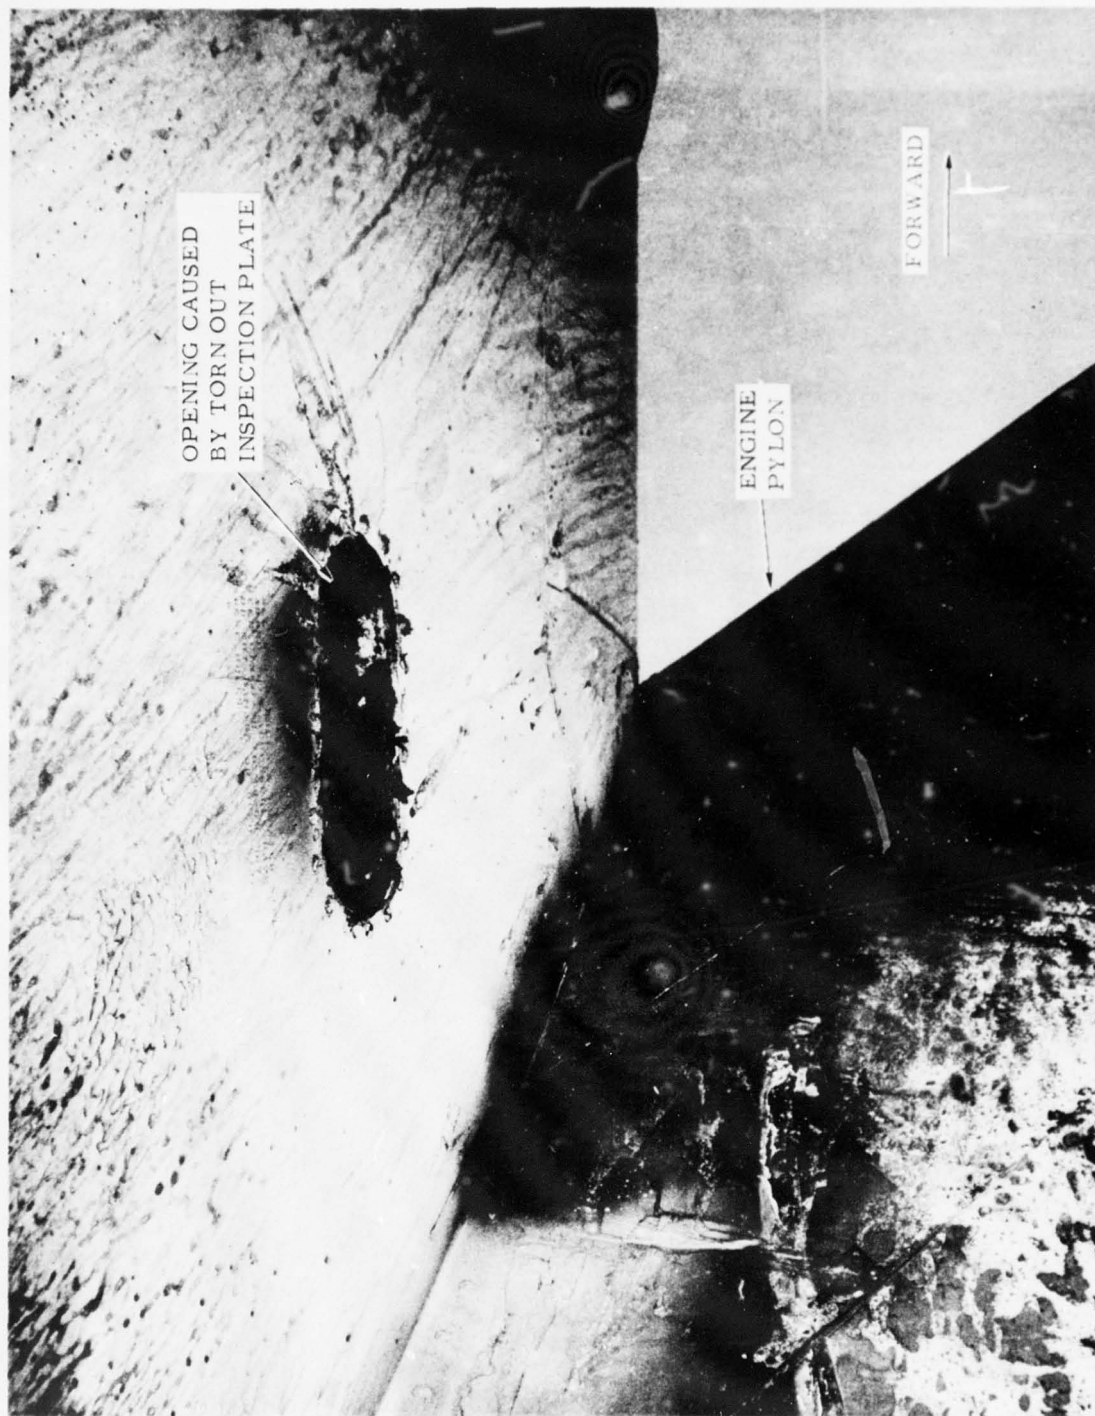
74-38-24

FIGURE 22. EXISTING OPENING IN FUEL TANK AFTER INSPECTION  
PLATE HAD BEEN PULLED OUT

The four inspection plate plugs that were attached to the landing gear by stainless steel cable lanyards were pulled out successfully and produced openings in the bottom of the wing tanks, as shown in figure 22. The four telephone poles caused large gaping openings in the leading edge of the wings, as shown in figure 24. The combination of these openings allowed copious quantities of fuel to pour out of the wing tanks as the airplane ploughed into the 3° sloped hill (figure 37). From the high-speed motion pictures taken during the test, it was determined that the fuel spewing from the ruptured tanks was ignited between the fuselage and the starboard engine which was running at the time. A fire developed at ground level in line with and aft of the starboard engine as the airplane slid along the 3° sloped hill and reached the crest of the hill. The propane torches burning at the top of the 3° sloped hill ignited the spilling fuel on the left side of the airplane. From that point on, the airplane was enveloped in flame as it passed down the test site area, and it continued to burn after it came to rest until the flames were extinguished by the fire fighters on the scene.

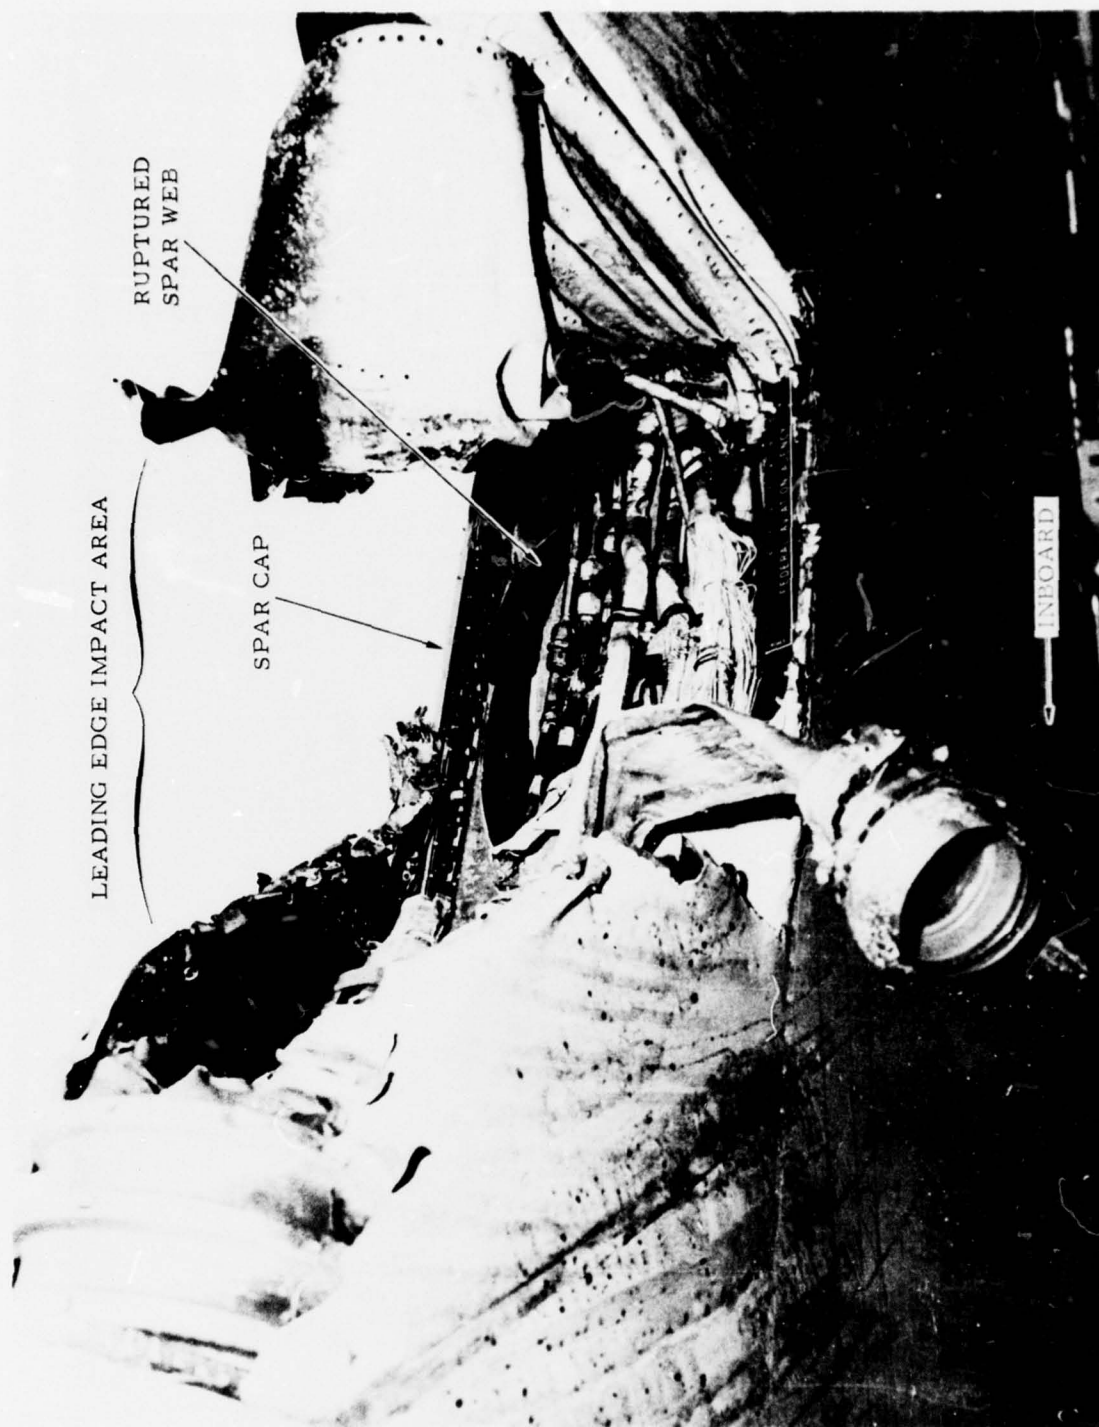
74-38-26

From the results of the previous tests, it was determined that the wing spar caps were protecting the spar web from damage when the wing leading edge contacted the telephone poles during the test. The wing spar web formed the front bulkhead of the integral wing tank, and if this web did not suffer structural failure, the fuel inside the tank would not be released. To increase the probability of failing, the spar web devices as shown in figure 23 were fabricated from structural iron shapes and located in the four positions of the wing leading edge that would contact the upright telephone pole obstacles in the test site area. The fabricated structural shape would be the first thing to contact the telephone poles and therefore would be driven through the spar web, thus rupturing the wing fuel tank. Figure 24 shows the type of structural failure that the wing tanks underwent during this test.

FIGURE 24. TYPE OF TANK RUPTURE PRODUCED IN TEST NO. 4

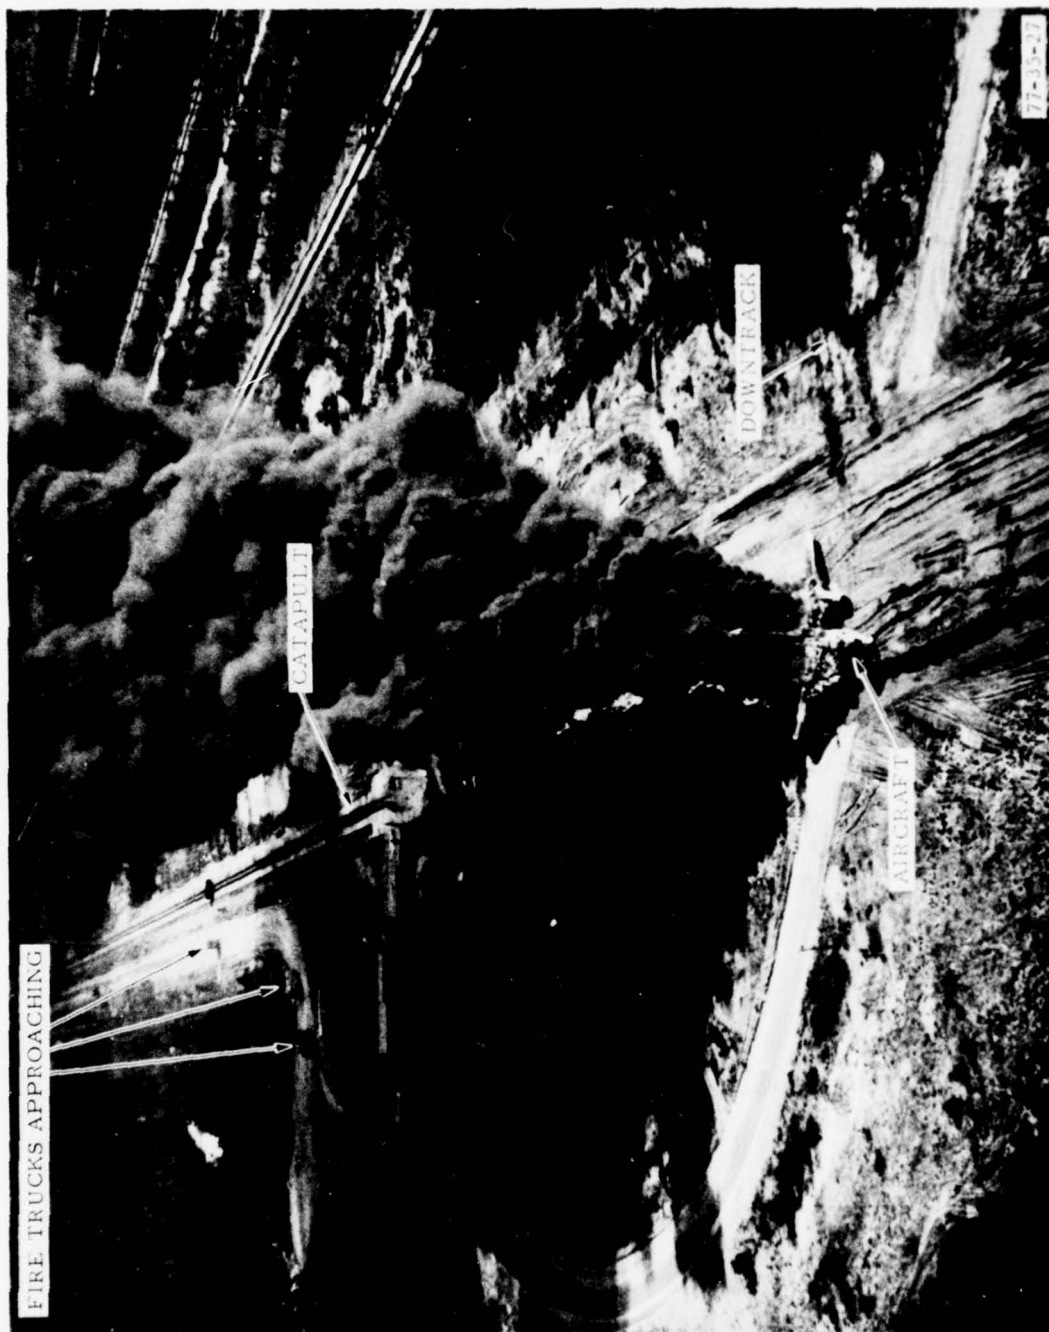
FIGURE 27. RESULTING FIRES FROM SPILLED FUEL DURING TEST NO. 4

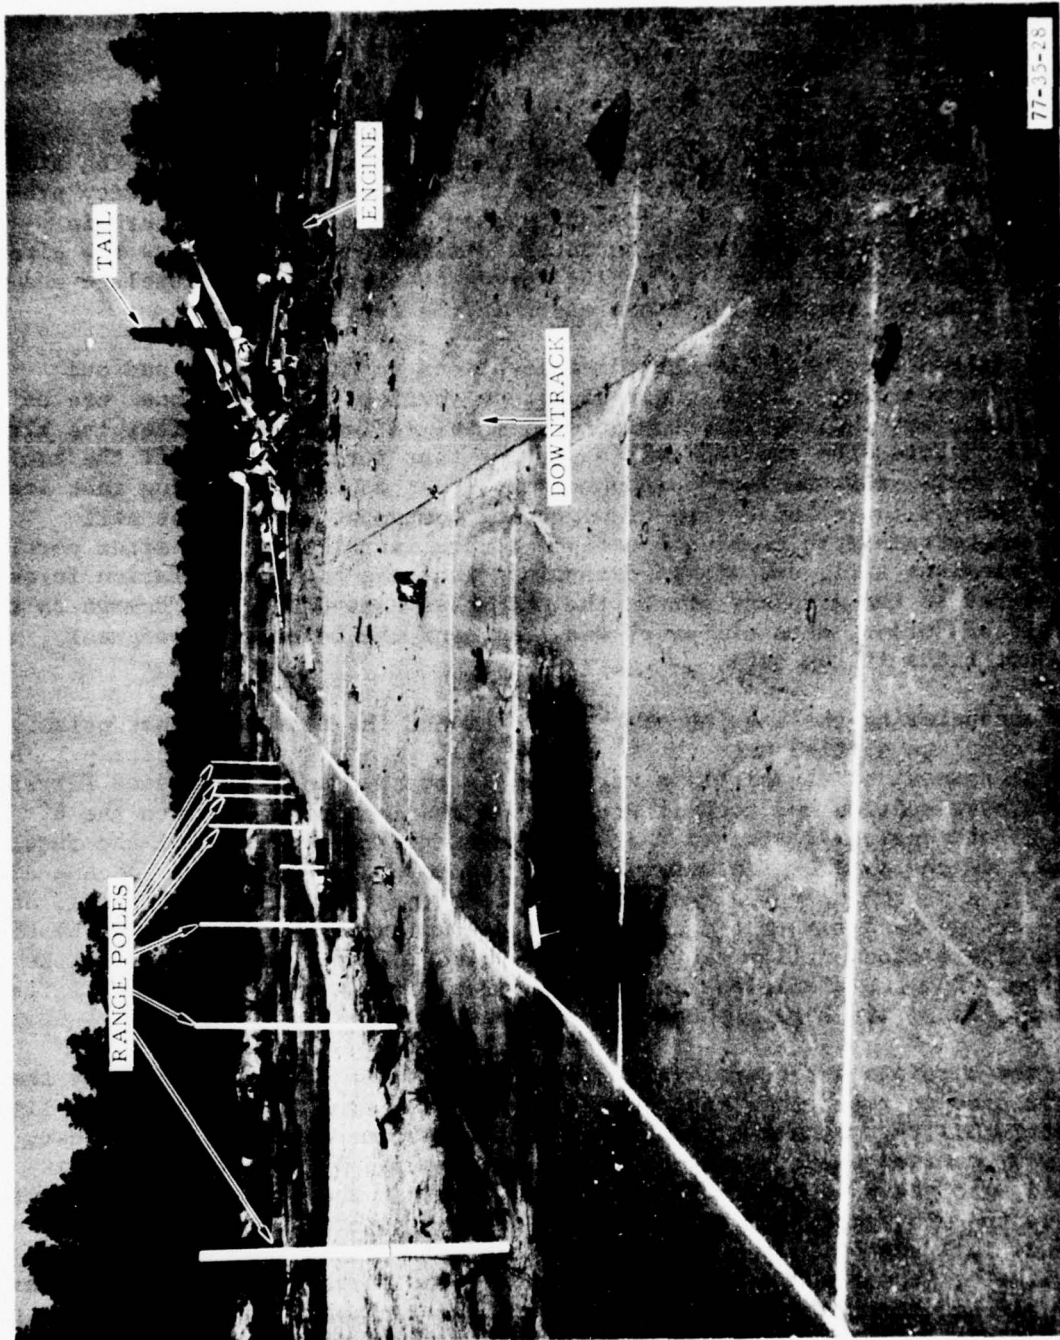
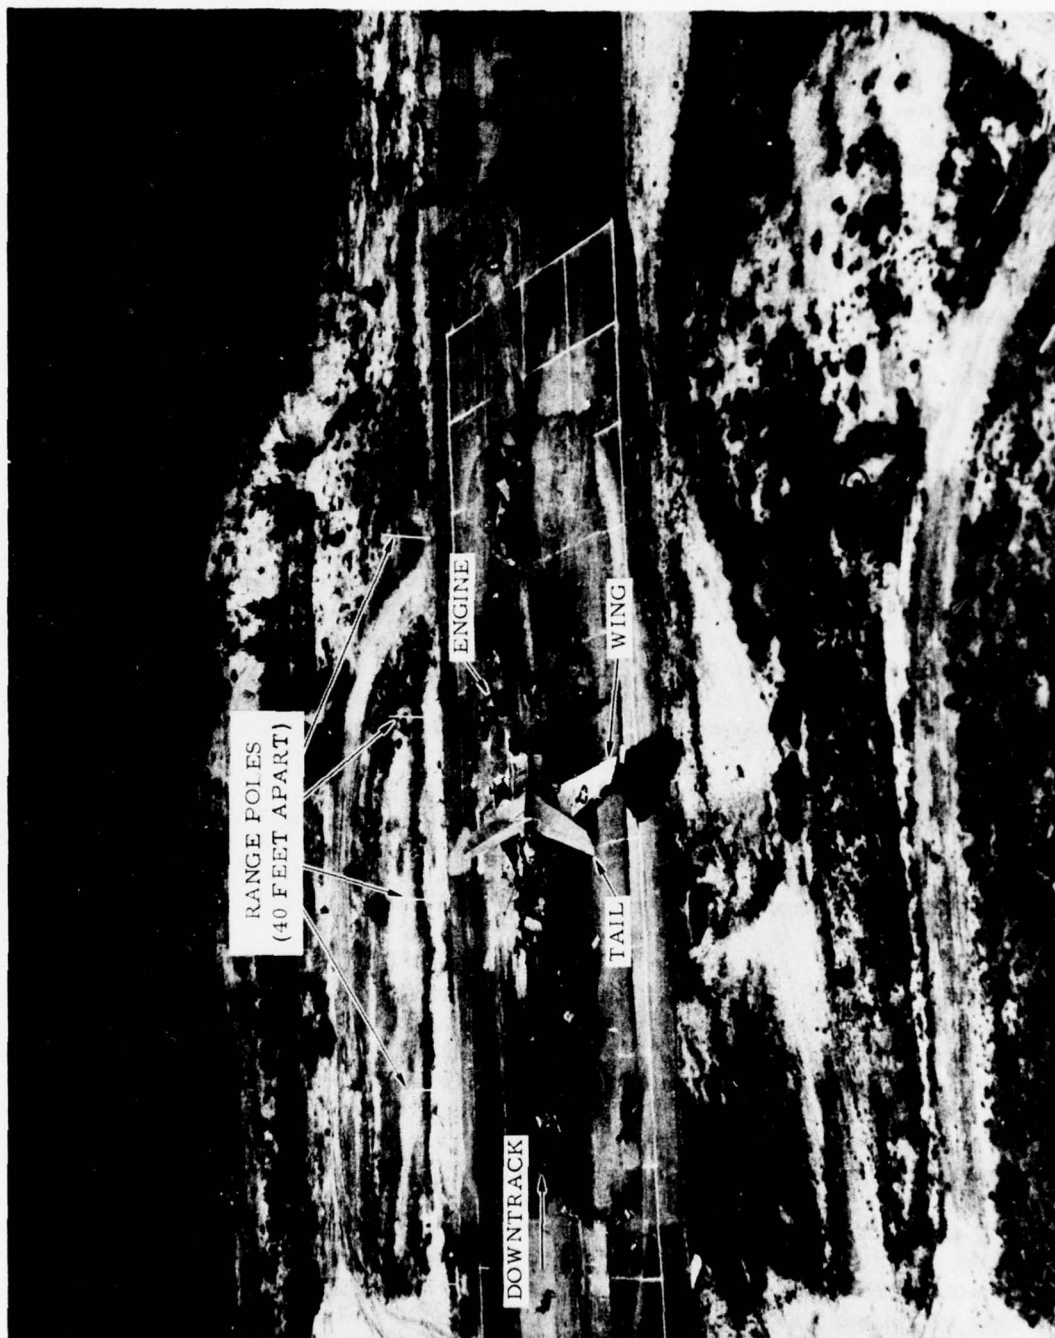
After encountering the landing gear obstacles and the four telephone poles, the A3 airplane settled onto the 6° sloped hill in a nose-down attitude. The vertical descent of the airplane was abruptly changed as it proceeded forward, and the nose section and cockpit area of the fuselage ploughed into the 6° slope. Both engines contacted the 6° slope as the forward part of the fuselage failed, and the port engine was torn from its mount. The airplane became airborne for approximately 190 feet after it left the crest of the 6° slope, and as it settled back toward the ground, the port wing contacted the edge of the 2-foot-high earthen pillow that was constructed 200 feet downtrack from the 6° slope. The whole airplane folded upon itself and came to rest in a large compact pile of wreckage, as shown in figures 28 and 29.

Since the airplane structural integrity had been completely destroyed by the time it came to rest, this test could not be considered to be within the limits of survivability. From the high-speed motion picture coverage of the test, it was determined that the impact forces encountered by the airplane as it settled onto the 6° sloped hill were so severe that they caused vital structures, such as the wing roots and engine-pod attachment points, to fail. As the airplane left the 6° slope, it appeared to be structurally sound, but more than likely, it was not. The movement of all the parts, wings, fuselage, and tail, through the air at the same velocity made it appear intact, but when the airplane settled back to ground level, there was not enough structural strength left to hold the various parts in their relative positions, and the airplane came to rest in a heap.

FIGURE 28. WRECKAGE OF A3 AIRPLANE OF TEST NO. 1 (LEFT REAR VIEW)

FIGURE 29. WRECKAGE OF A3 AIRPLANE OF TEST NO. 1 (OVERHEAD RIGHT SIDE VIEW)

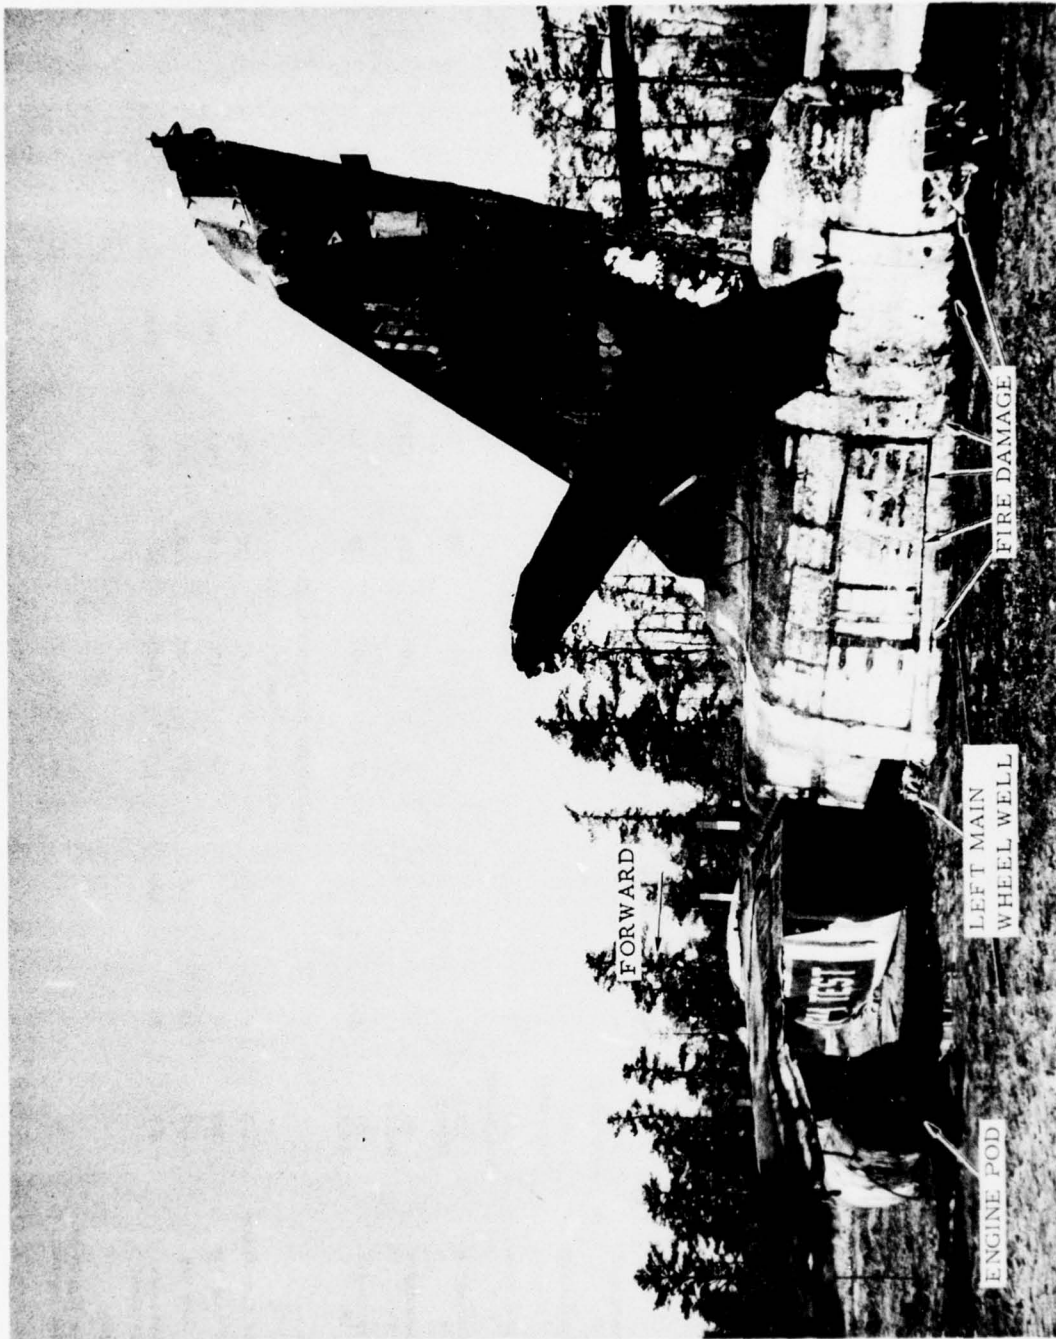
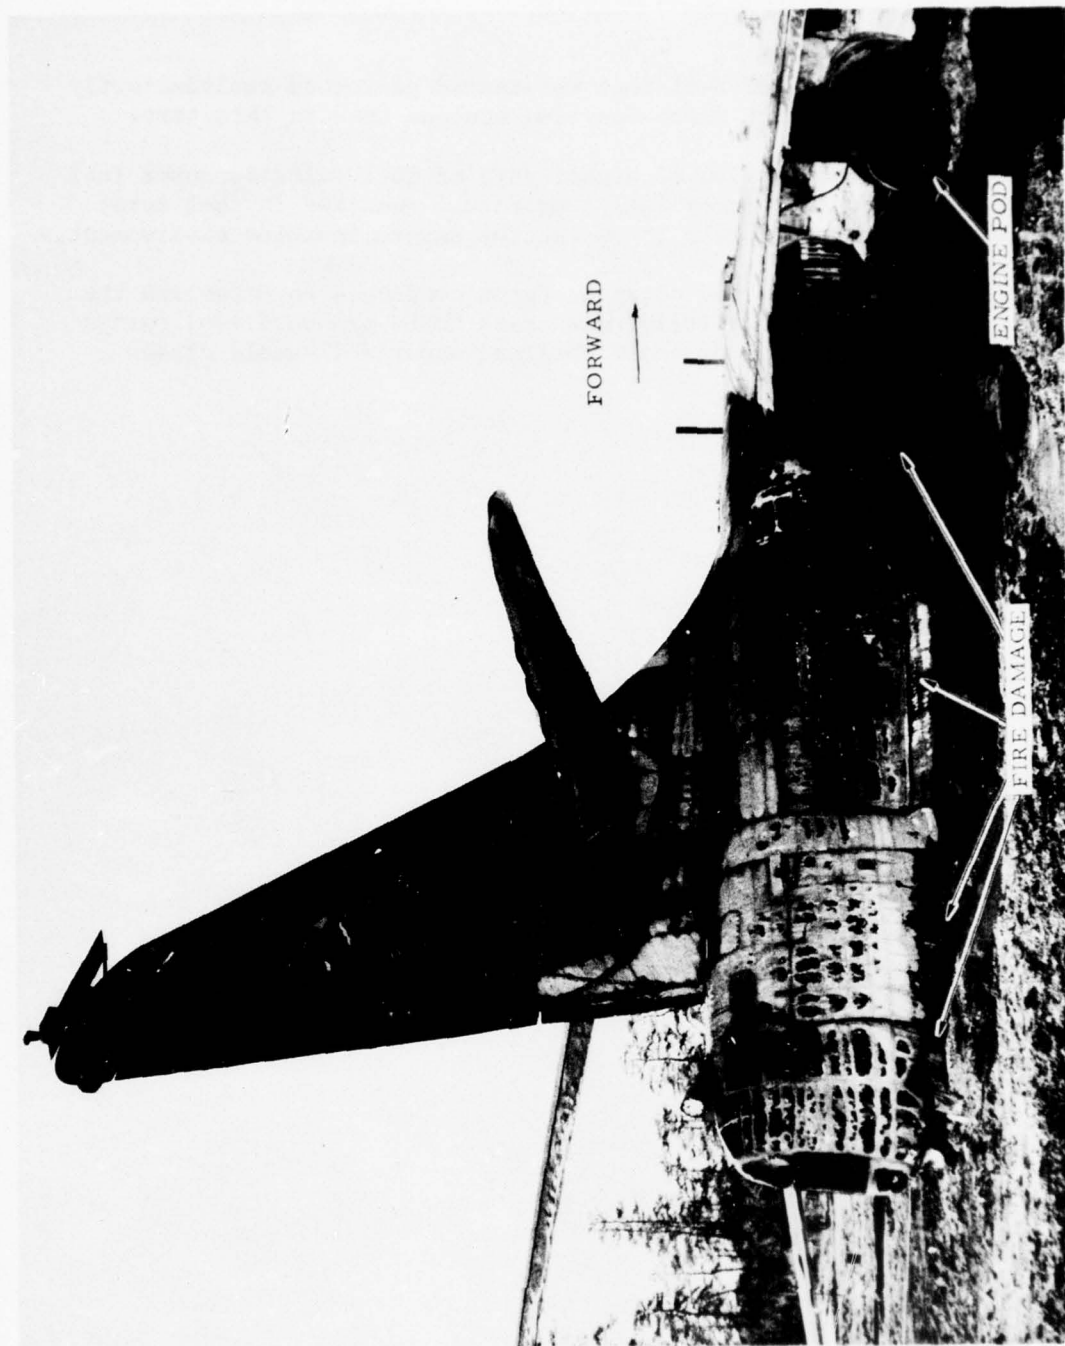
The fire had to be extinguished by the fire-fighting crew that was standing by at the crash site area. Figures 38 and 39 show the hulk of the airplane after the fires were extinguished. The fires were confined to that part of the airplane aft of the wing leading edge mainly because the forward velocity of the airplane caused the spilled fuel and flames to propagate aft, and also because the airplane came to rest with its nose pointed into the prevailing wind. Therefore, the cockpit area of the fuselage was relatively free of fire and heat.

FIGURE 38. LEFT-SIDE VIEW OF RB66 AIRPLANE USED IN TEST NO. 4

FIGURE 39. RIGHT-SIDE VIEW OF RB66 AIRPLANE USED IN TEST NO. 4
